State of Utah  
DEPARTMENT OF NATURAL RESOURCES  
DIVISION OF OIL, GAS AND MINING

RE: Site Inspection, Native Asphalt Company, Cameron #1 Mine, S/047/036, Uintah County, Utah

Date of Inspection: October 17, 1994  
Time of Inspection: 1120 - 1245  
Conditions: Raining, cool  
Participants: John Robinson, Contractor; Tony Gallegos, DOGM

Purpose of Inspection: To examine reclamation currently being performed

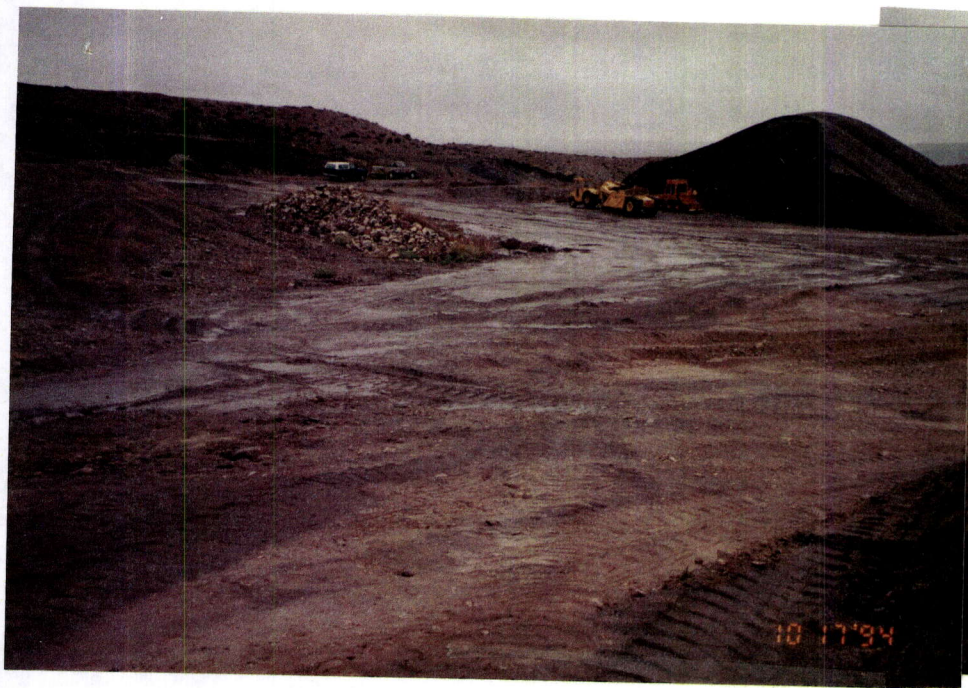
S/047/036

- NOTE OVERBURDEN MATERIAL (SOILS)  
HAVE BEEN REMOVED FROM THIS  
AREA AND PLACED ON SCALPED HILLSIDE

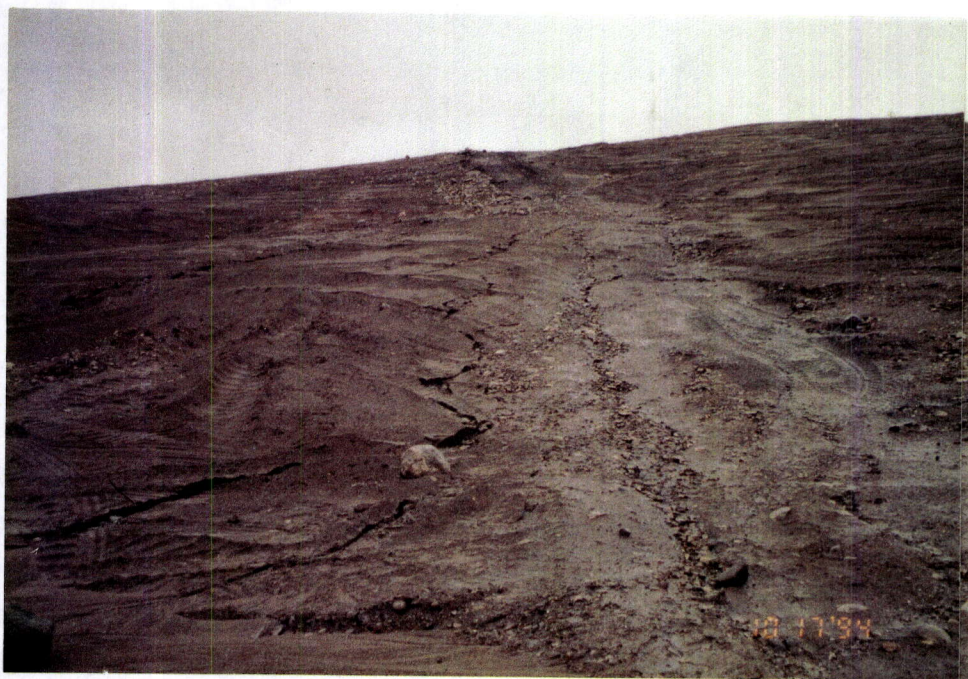
S/047/036

SOIL PLACEMENT ON SCALPED  
HILLSIDE

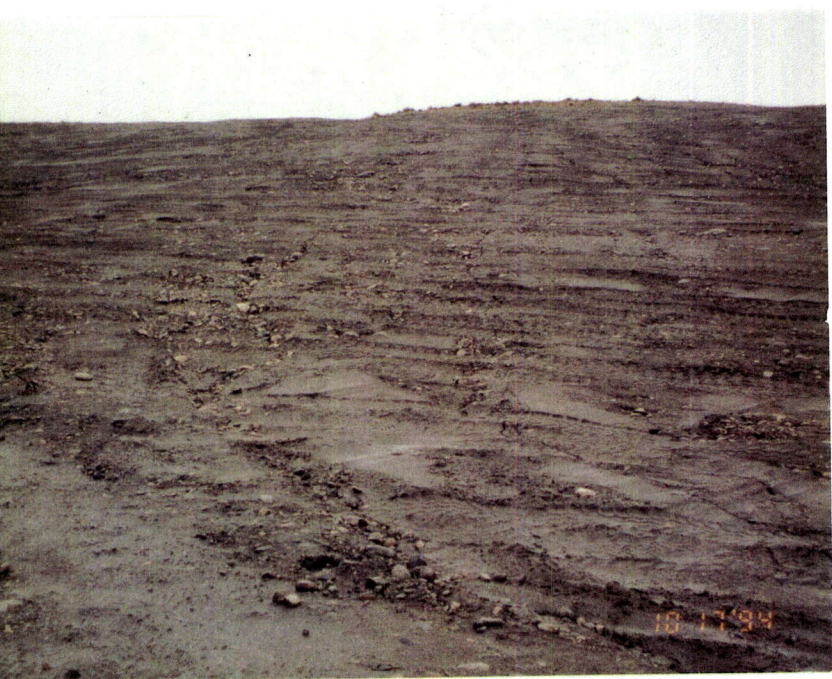
S/047/036

SOIL PLACED ON SCALPED HILLSIDE

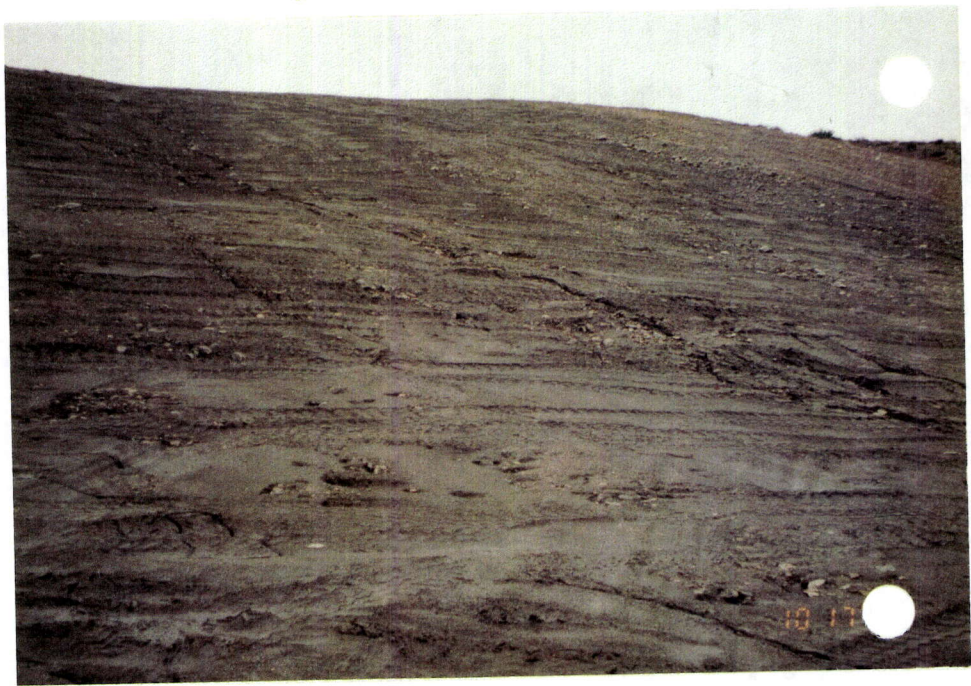
S/047/036

SOIL PLACEMENT ON OLD  
ASPHALT PAD & HILLSIDE

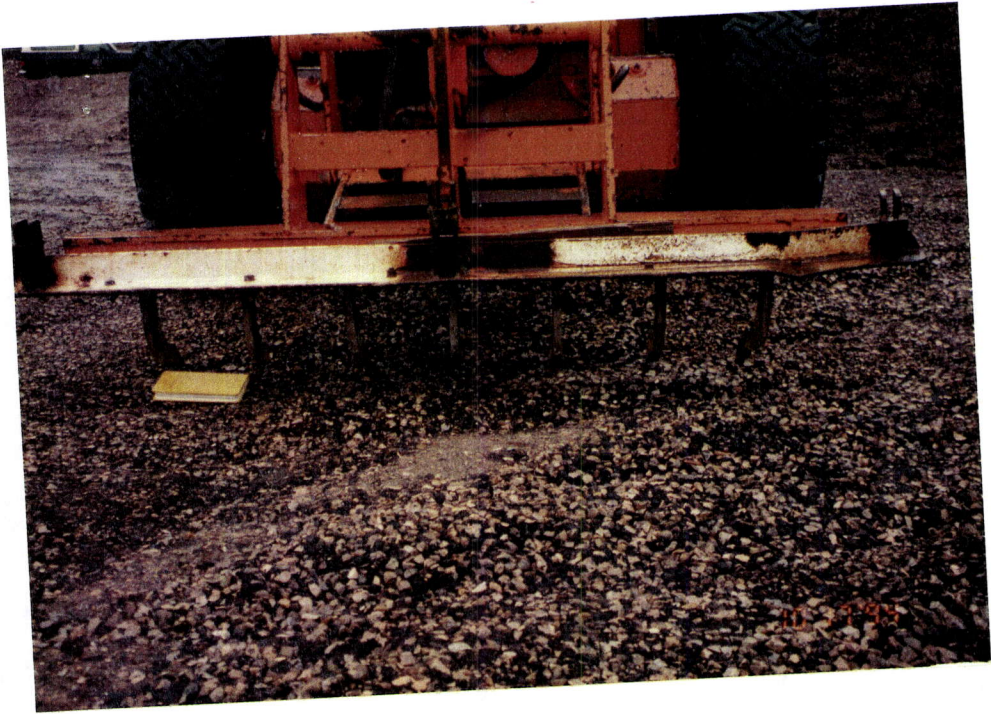
S/047/036

-DETAIL OF RIPPERS ON GRADER  
TO BE USED TO RIP/SCARIFY  
TOPSOILED AREAS

After viewing the site and the equipment Mr. Robinson intends to use to perform the scarifying and seeding, it was decided that the areas which have been topsoiled would be ripped with the motor grader. This will rip the surface possibly as deep as 6" or less. Ripper teeth are placed approximately 8" apart. Immediately after ripping, the area would be broadcast seeded.

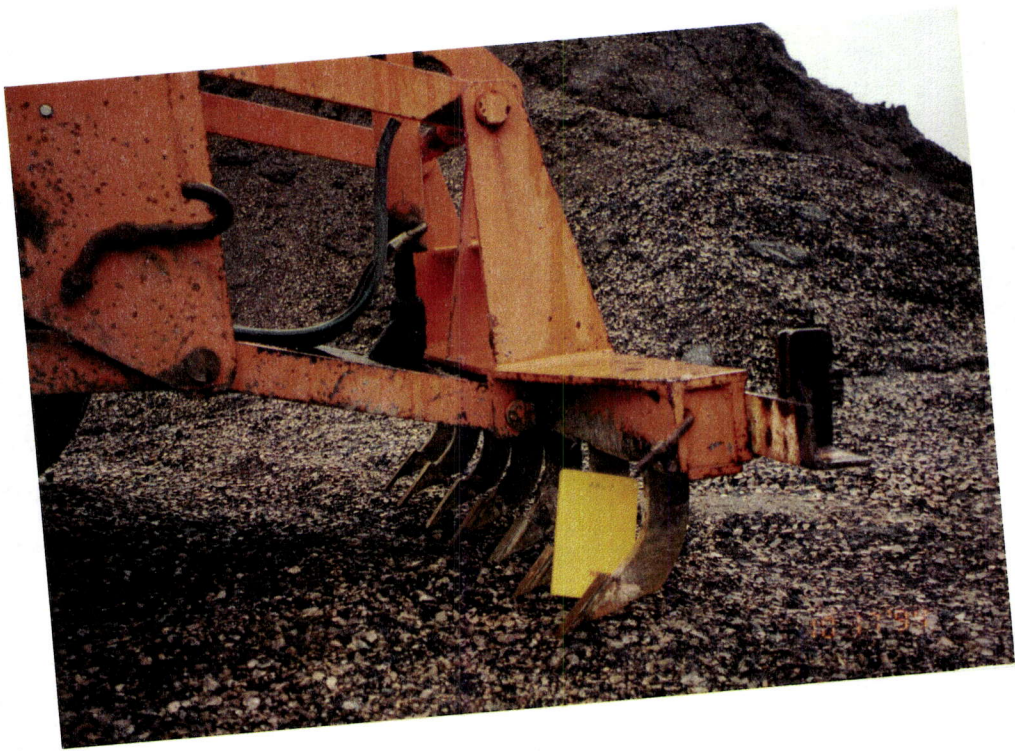
S/047/036

DETAIL OF RIPPERS ON OLD GRADER  
-PLAN TO RIP/SCARIFY THE TOPSOILED  
AREAS
